The preferred **Process** to fix your Home's Foundation Settlement

## PUSH PIER SYSTEM

## The preferred Solution for your Home's Foundation Settlement

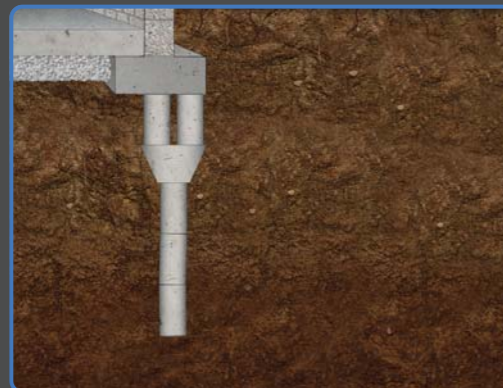
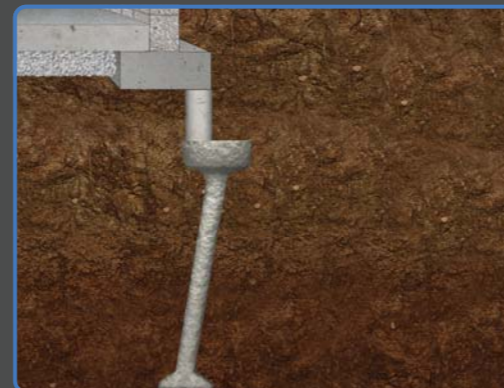
### Tear Out and Replacement

Very expensive process  
Doesn't address the problem  
(additional settlement is likely to occur)  
Very disruptive

### Concrete Pressed Piles

Relies on skin friction to carry load  
Not installed past the active soil zone  
Call-backs are very common

### Drilled Concrete Piers

Very disruptive and messy  
Not installed past the active soil zone  
Call-backs are very common
